**Attachment S -
Pine Chapel Maintenance Yard**

**VDOT MS4 (General Permit No. VAR04)
Pine Chapel Area Headquarters
VDOT District No. 5**

Facility Name: Pine Chapel Area Headquarters
Location: 150 E Street, Hampton, VA, 23661
Latitude: N 37.00792* **Longitude:** W 76.40686*

Date of Visit: October 24, 2012
Entry Time: 10:50 a.m. (approx)
Exit Time: 11:56 a.m. (approx)

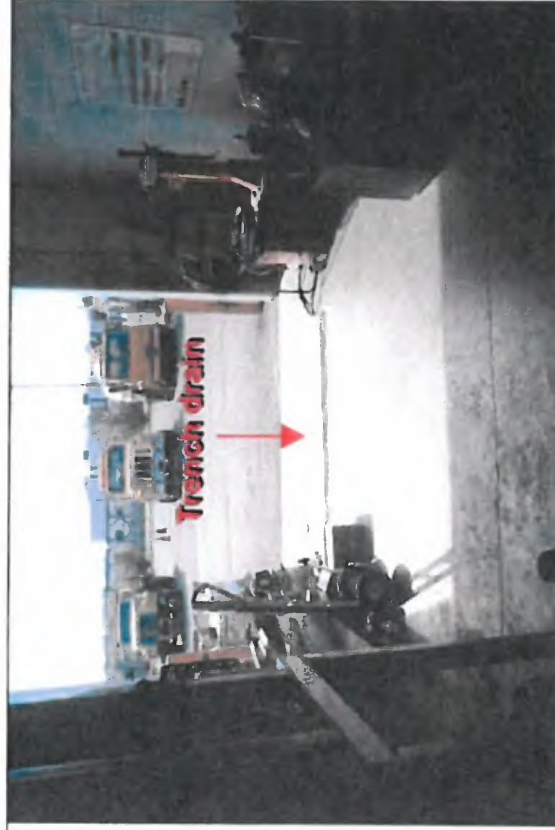
4. Floor trench drains were observed in the equipment maintenance shop building and the vehicle/equipment wash bay (see Photographs 1 and 2). The VDOT Equipment Repair Tech stated that he believed the floor drains were connected to an oil/water separator that discharged to the Hampton Roads Sanitation District sanitary sewer system. The VDOT Tunnels Maintenance Superintendent stated that he was pretty sure of this as well. The EPA Inspection Team did not view drainage schematics for the Facility to confirm this discharge location.

Photograph 1 – View of floor trench drain in equipment maintenance shop building.

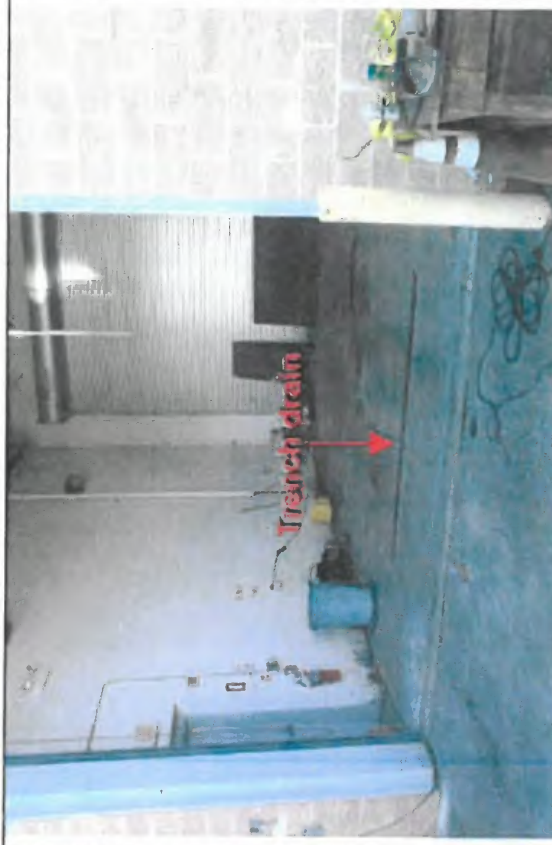
Photograph 2 – View of vehicle/equipment wash bay with floor trench drain.

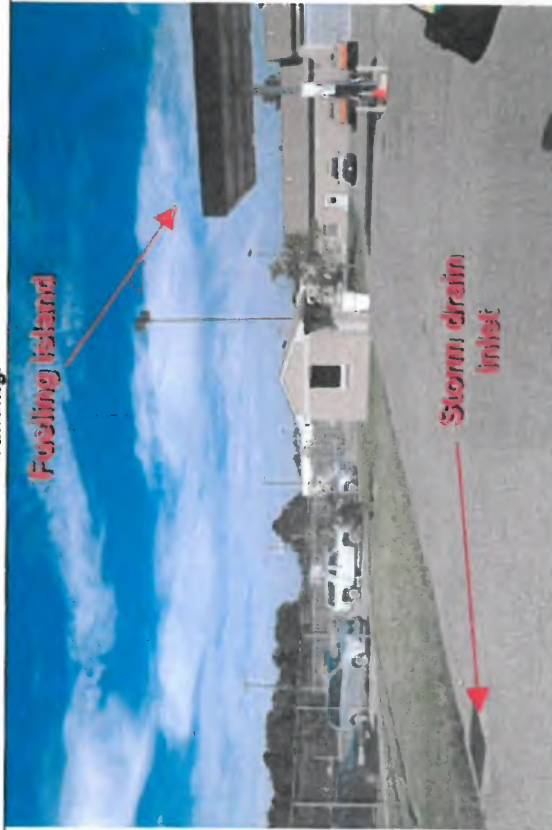
5. A storm drain drop inlet without BMPs for inlet protection was located about 60 feet to the south/southwest of the covered fueling island, directly to the west of the equipment maintenance shop (see Photographs 3 and 4).

Photograph 3 – View of storm drain inlet without BMPs for inlet protection to south/southwest of covered fueling island.

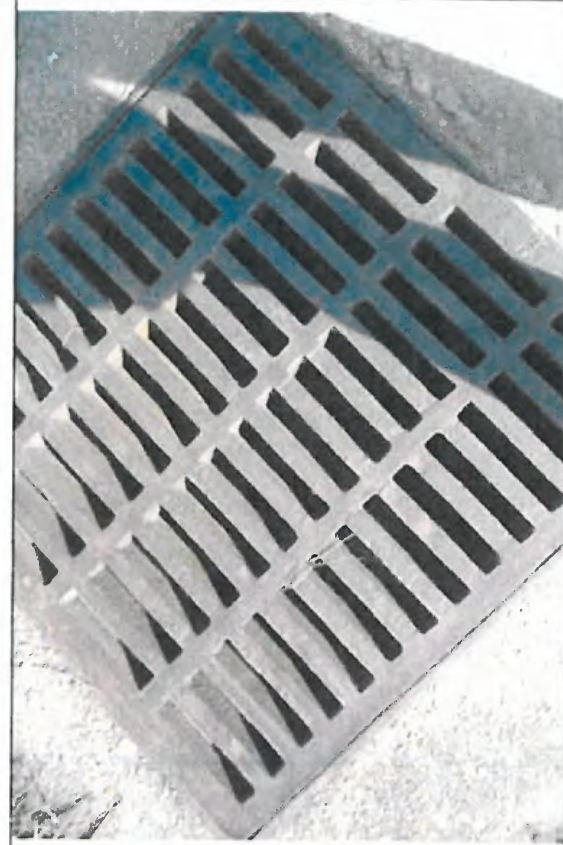
Photograph 4 – Close-up view of storm drain inlet shown in Photo 3

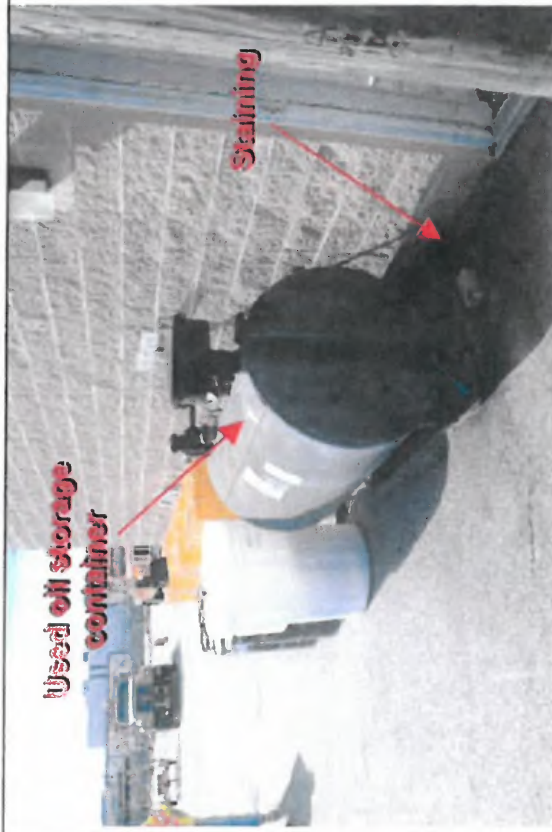
6. Staining was observed on the impervious ground surface adjacent to the used oil storage container on the east side of the equipment maintenance shop building (see Photographs 5 and 6). A storm drain drop inlet without BMPs for inlet protection was located downgradient about 60 feet to the south/southeast of the used oil storage container (see Photograph 7). In addition, loose gravel was present adjacent to the storm drain inlet (see Photograph 7).

Photograph 5 – View of used oil storage container on east side of the equipment maintenance shop building.

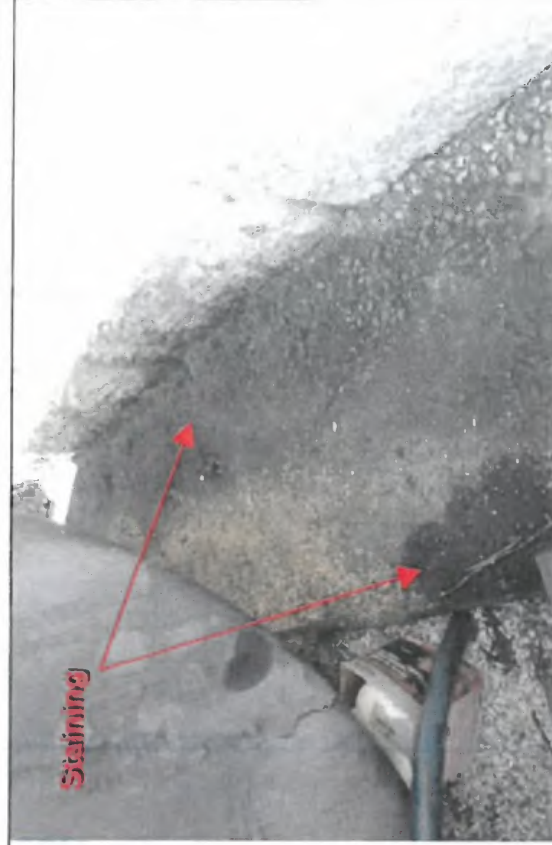
Photograph 6 – Closer view of staining shown in Photo 5.

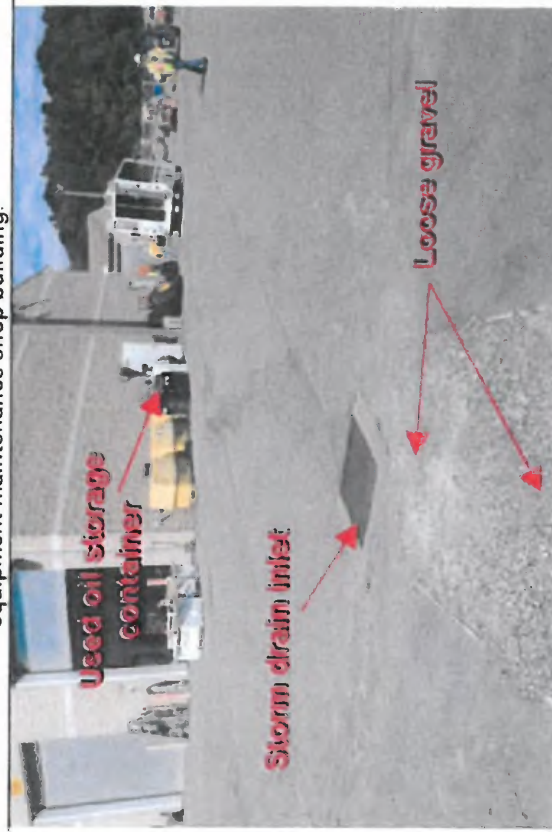
Photograph 7 – View of storm drain inlet downgradient of used oil storage container shown in Photo 5.

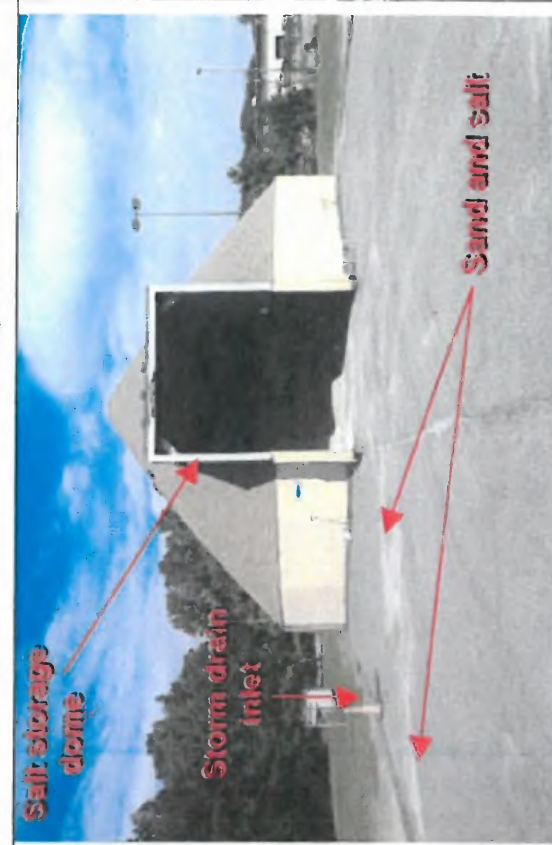
7. Sand and salt was present on the impervious ground surface in front of the salt storage dome in an area upgradient of a storm drain inlet without BMPs for inlet protection (see Photographs 8, 9, and 10). The VDOT Facility Superintendent explained that the storm drain inlet was equipped with a valve that could be engaged to divert flow to an underground storage tank rather than to the drainage ditch located about 50 feet to the west (see Photographs 11 and 12). He stated that the valve would be engaged at the beginning of the winter season so that the storm drain would direct flow to the underground storage tank during salt loading and unloading operations. The VDOT Facility Superintendent also explained that vehicles are washed at the end of "snow season" in the area directly in front of the salt storage dome. He stated that the valve would be opened after snow season was complete and that the valve was open at the time of the EPA Inspection Team's visit to the Facility. The VDOT Facility Superintendent stated that Bay Environmental was contracted to pump out the storage tank and dispose of the material.

Photograph 8 – View of salt storage dome and paved area in front of salt storage dome.

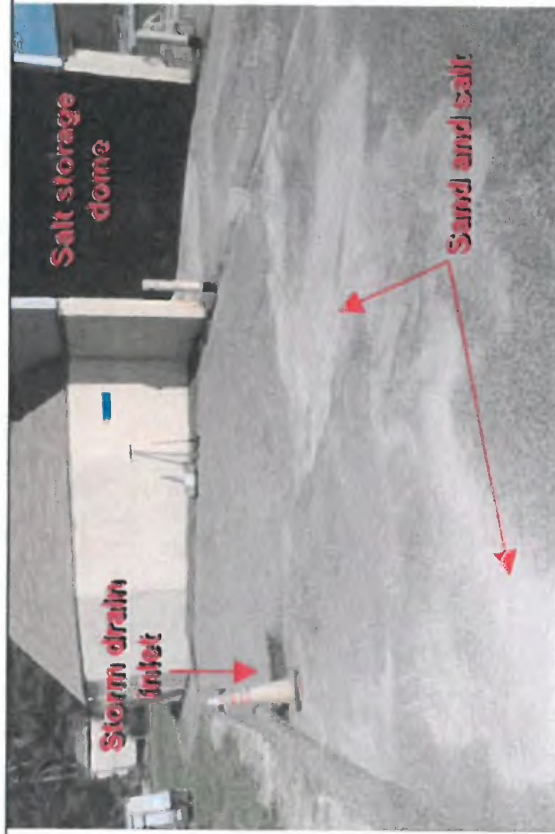
Photograph 9 – Additional view of salt storage dome and nearby storm drain inlet.

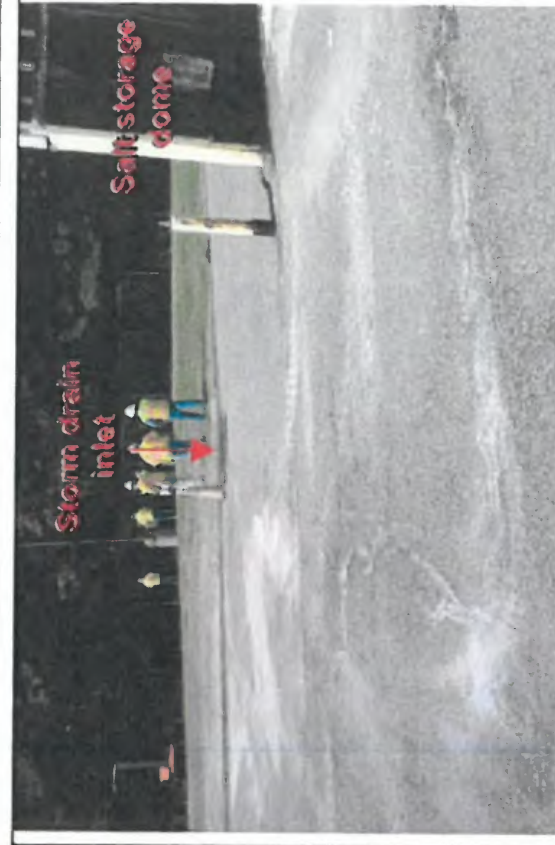
Photograph 10 – Additional view of salt storage dome and nearby storm drain inlet.

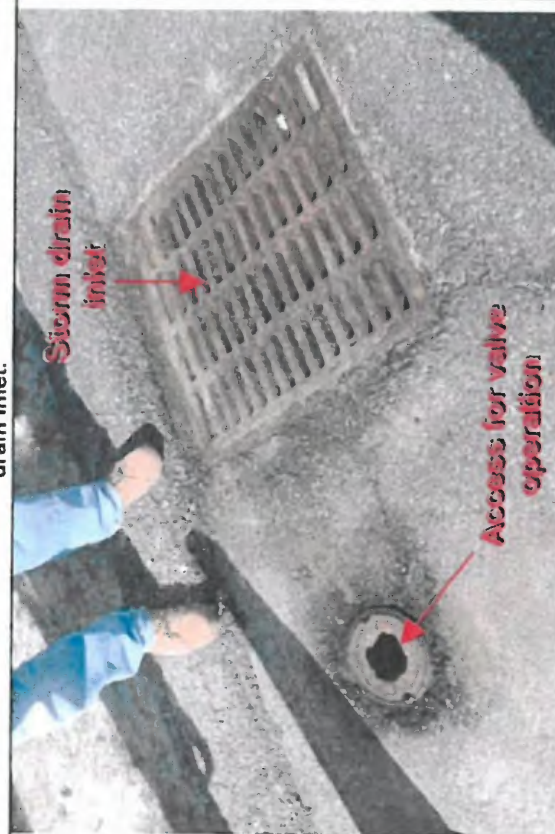
Photograph 11 – View of storm drain inlet shown in Photos 8, 9, and 10.
Note access for operating diversion valve

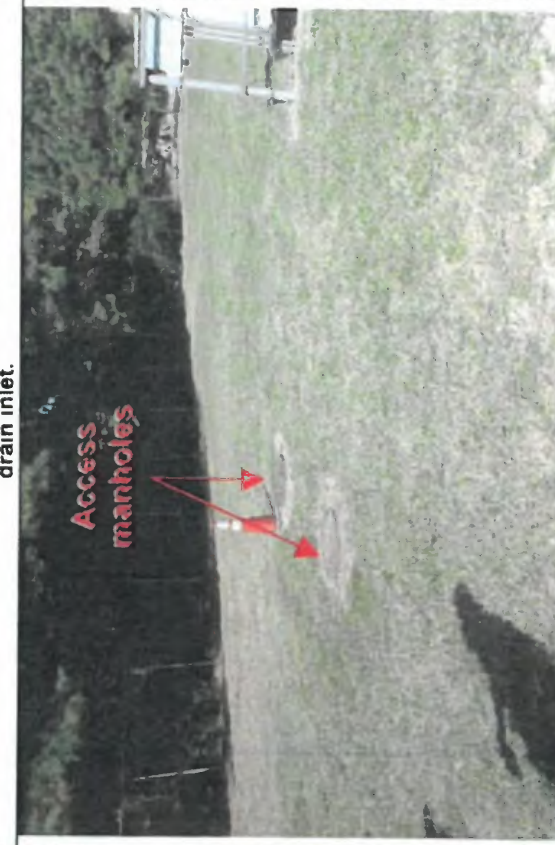
Photograph 12 – View of area where underground storage tank is located and access manholes to the storage tank.

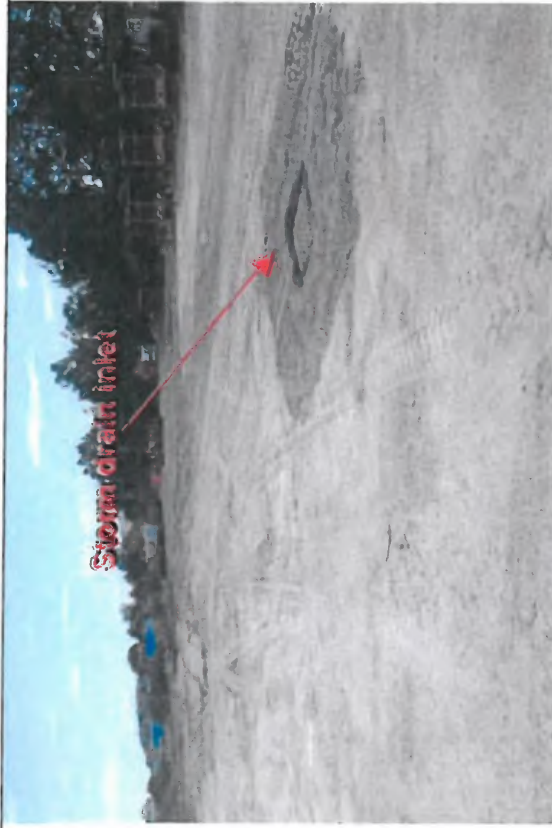
8. A storm drain inlet without BMPs for inlet protection was located in an unpaved area about 120 feet to the southeast of the salt storage dome (see Photographs 13 and 14). It appeared to the EPA Inspection Team that asphalt had recently been applied around the edges of the storm drain inlet.

Photograph 13 – View of storm drain inlet in unpaved area to southeast of salt storage dome.

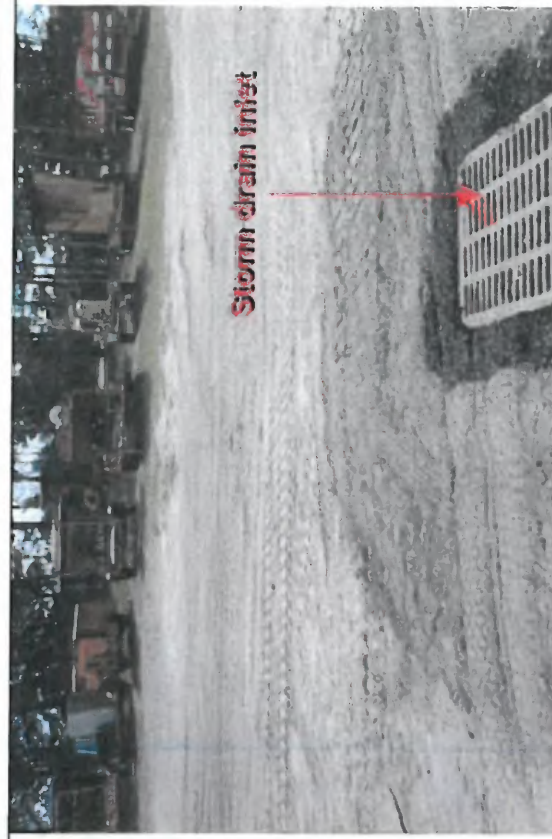
Photograph 14 – Closer view of storm drain inlet shown in Photo 13.
[NOTE: Do we have a discharge point photo for this ?]

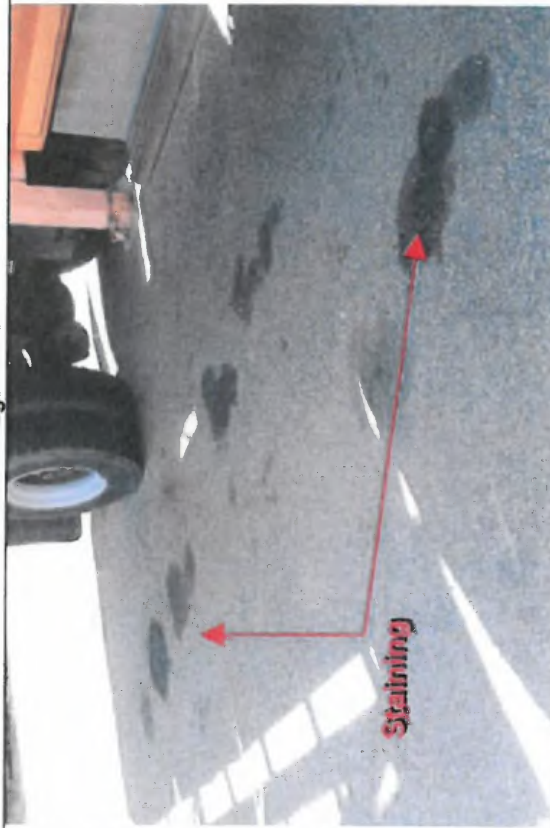
9. Staining of what appeared to be petroleum-based products was observed on the impervious ground surface adjacent to dump trucks and vacuum trucks stored near the spreader racks in the northeastern portion of the main section of the Facility (see Photographs 15 and 16). Sand, orange rust staining, and debris was also present on the impervious ground surface in this area (see Photographs 17, 18, and 19). A storm drain inlet without BMPs for inlet protection was located about 90 feet to the west. A photograph showing the storm drain inlet itself was not obtained by the EPA Inspection Team.

Photograph 15 – View of staining on impervious ground surface near the spreader racks in the northeastern portion of the main section of the Facility.

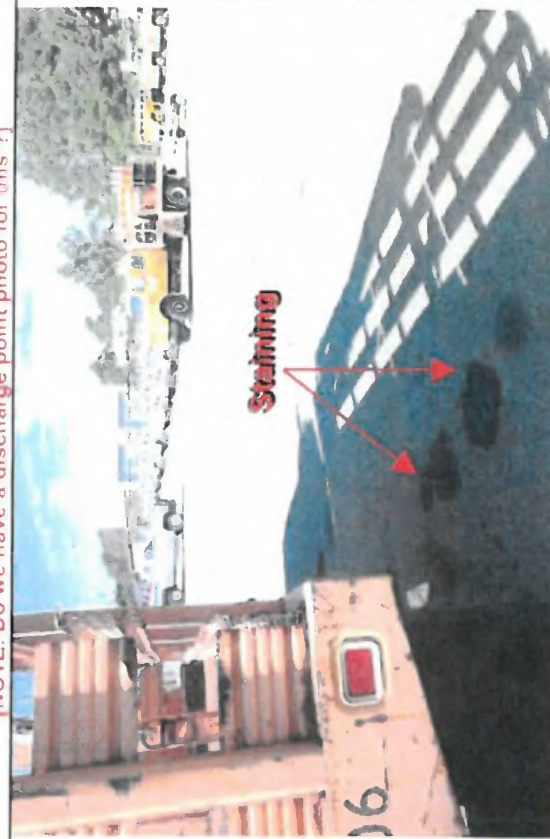
Photograph 16 – Additional example of staining on impervious ground surface.

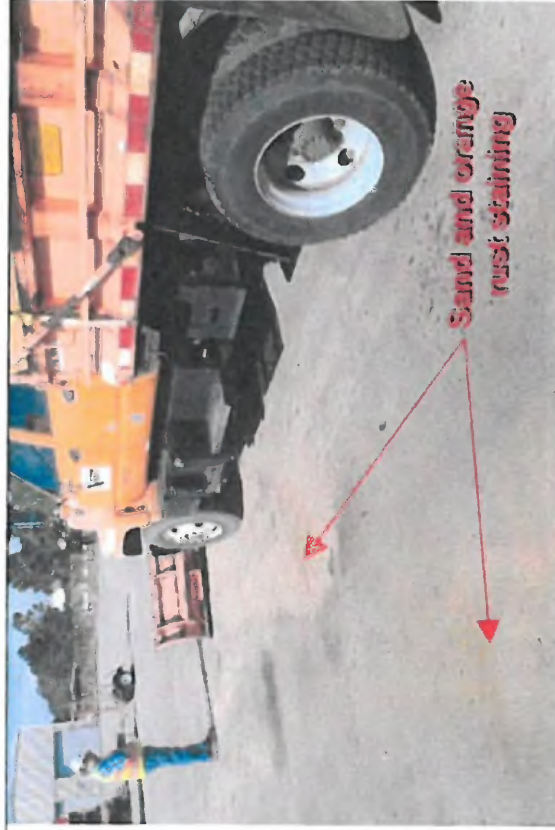
Photograph 17 – View of sand and orange rust staining on impervious ground surface.

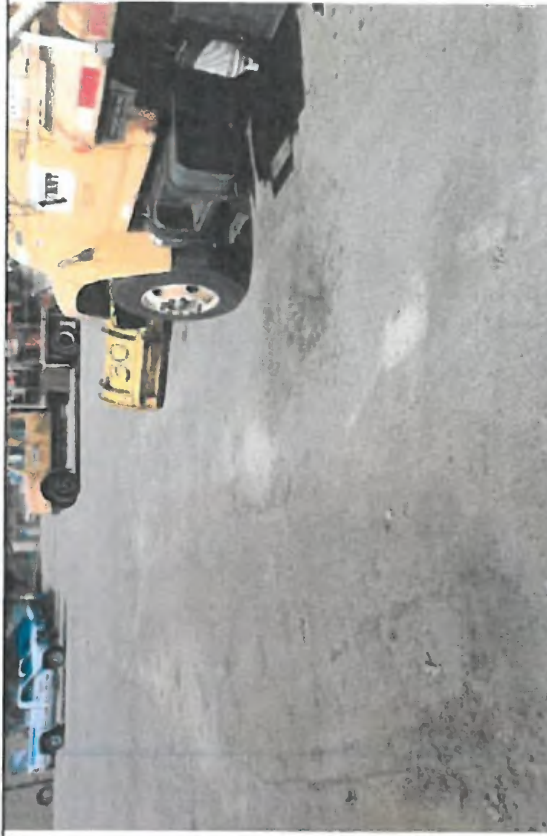
Photograph 18 – Additional example of orange rust staining and debris on impervious ground surface.

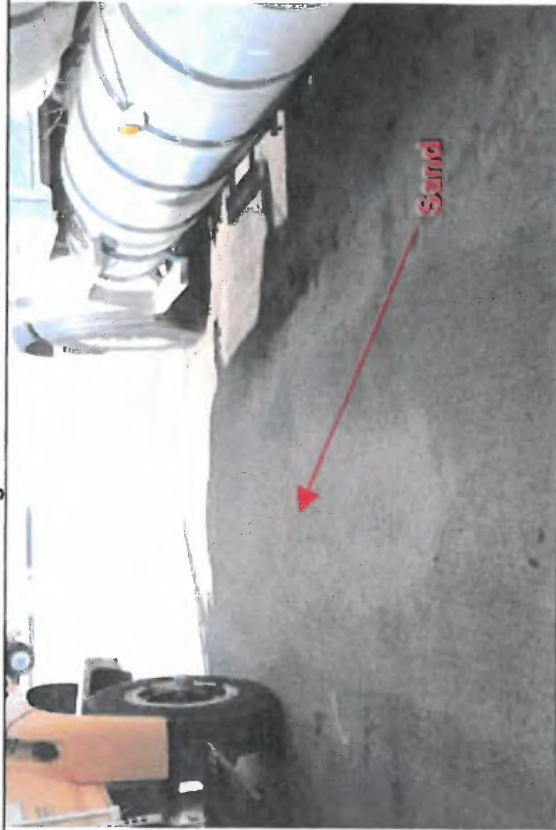
Photograph 19 – View of sand on impervious ground surface between a dump truck and a vacuum truck.

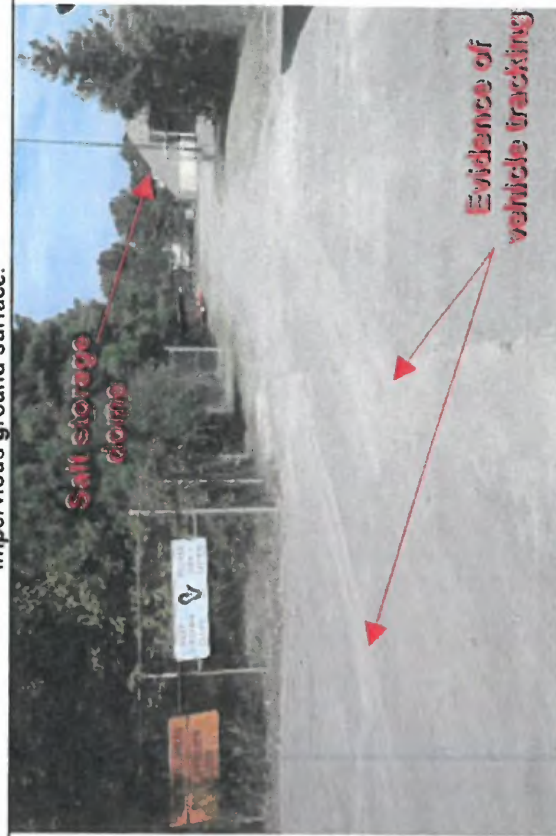
10. Sediment from vehicle tracking was observed on the impervious ground surface adjacent to the rock-lined entrance to the area where the salt dome was located, to the northeast of the main section of the Facility (see Photographs 20, 21, and 22). A storm drain inlet without BMPs for inlet protection was located about 175 feet to the southwest. A photograph showing the storm drain inlet itself was not obtained by the EPA Inspection Team.

Photograph 20 – View of entrance to area with salt storage dome. Note presence of sediment from vehicle tracking on impervious ground surface.

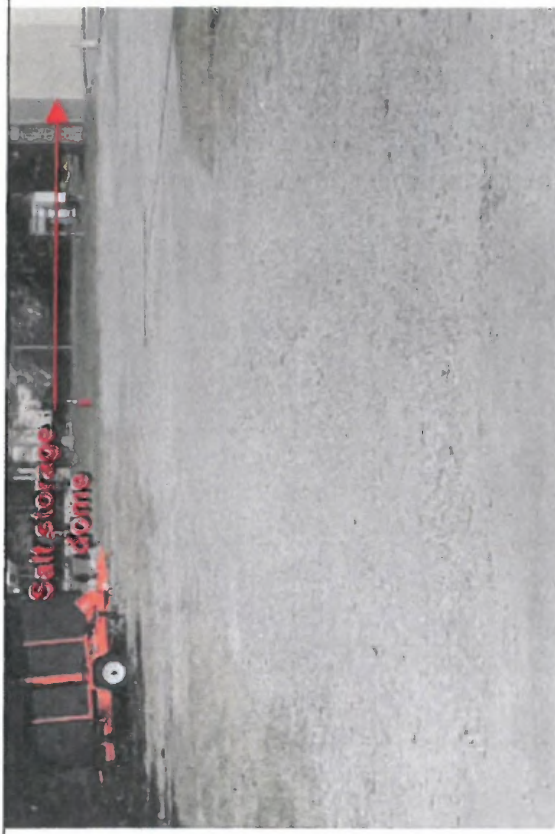
Photograph 21 – Closer view of rock-lined entrance to area with salt storage dome.

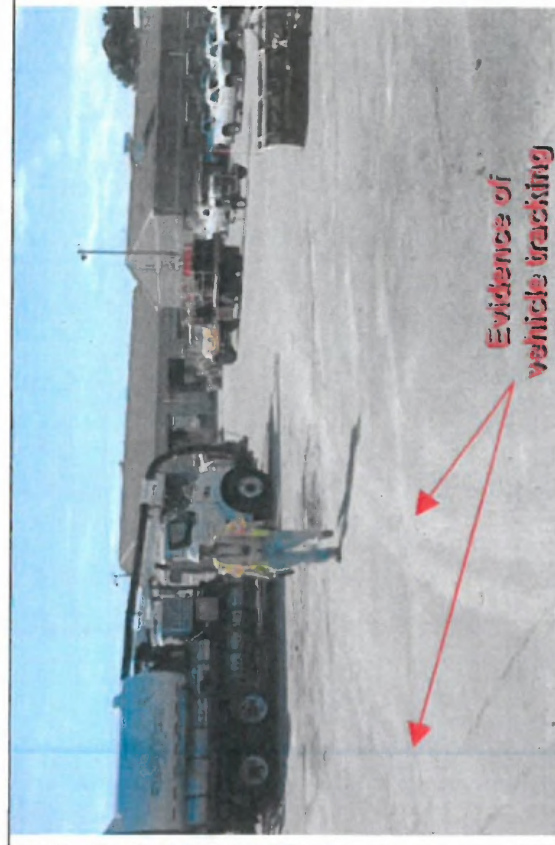
Photograph 22 -- View from rock-lined entrance shown in Photo 21 toward main section of Facility to the southwest.
